# **Distribution Construction**

## **Inspection Findings**

New England Pipeline Safety Seminar  
October 20, 2010

Karl Baker – CT DPUC  
Gary Kenny – ME PUC

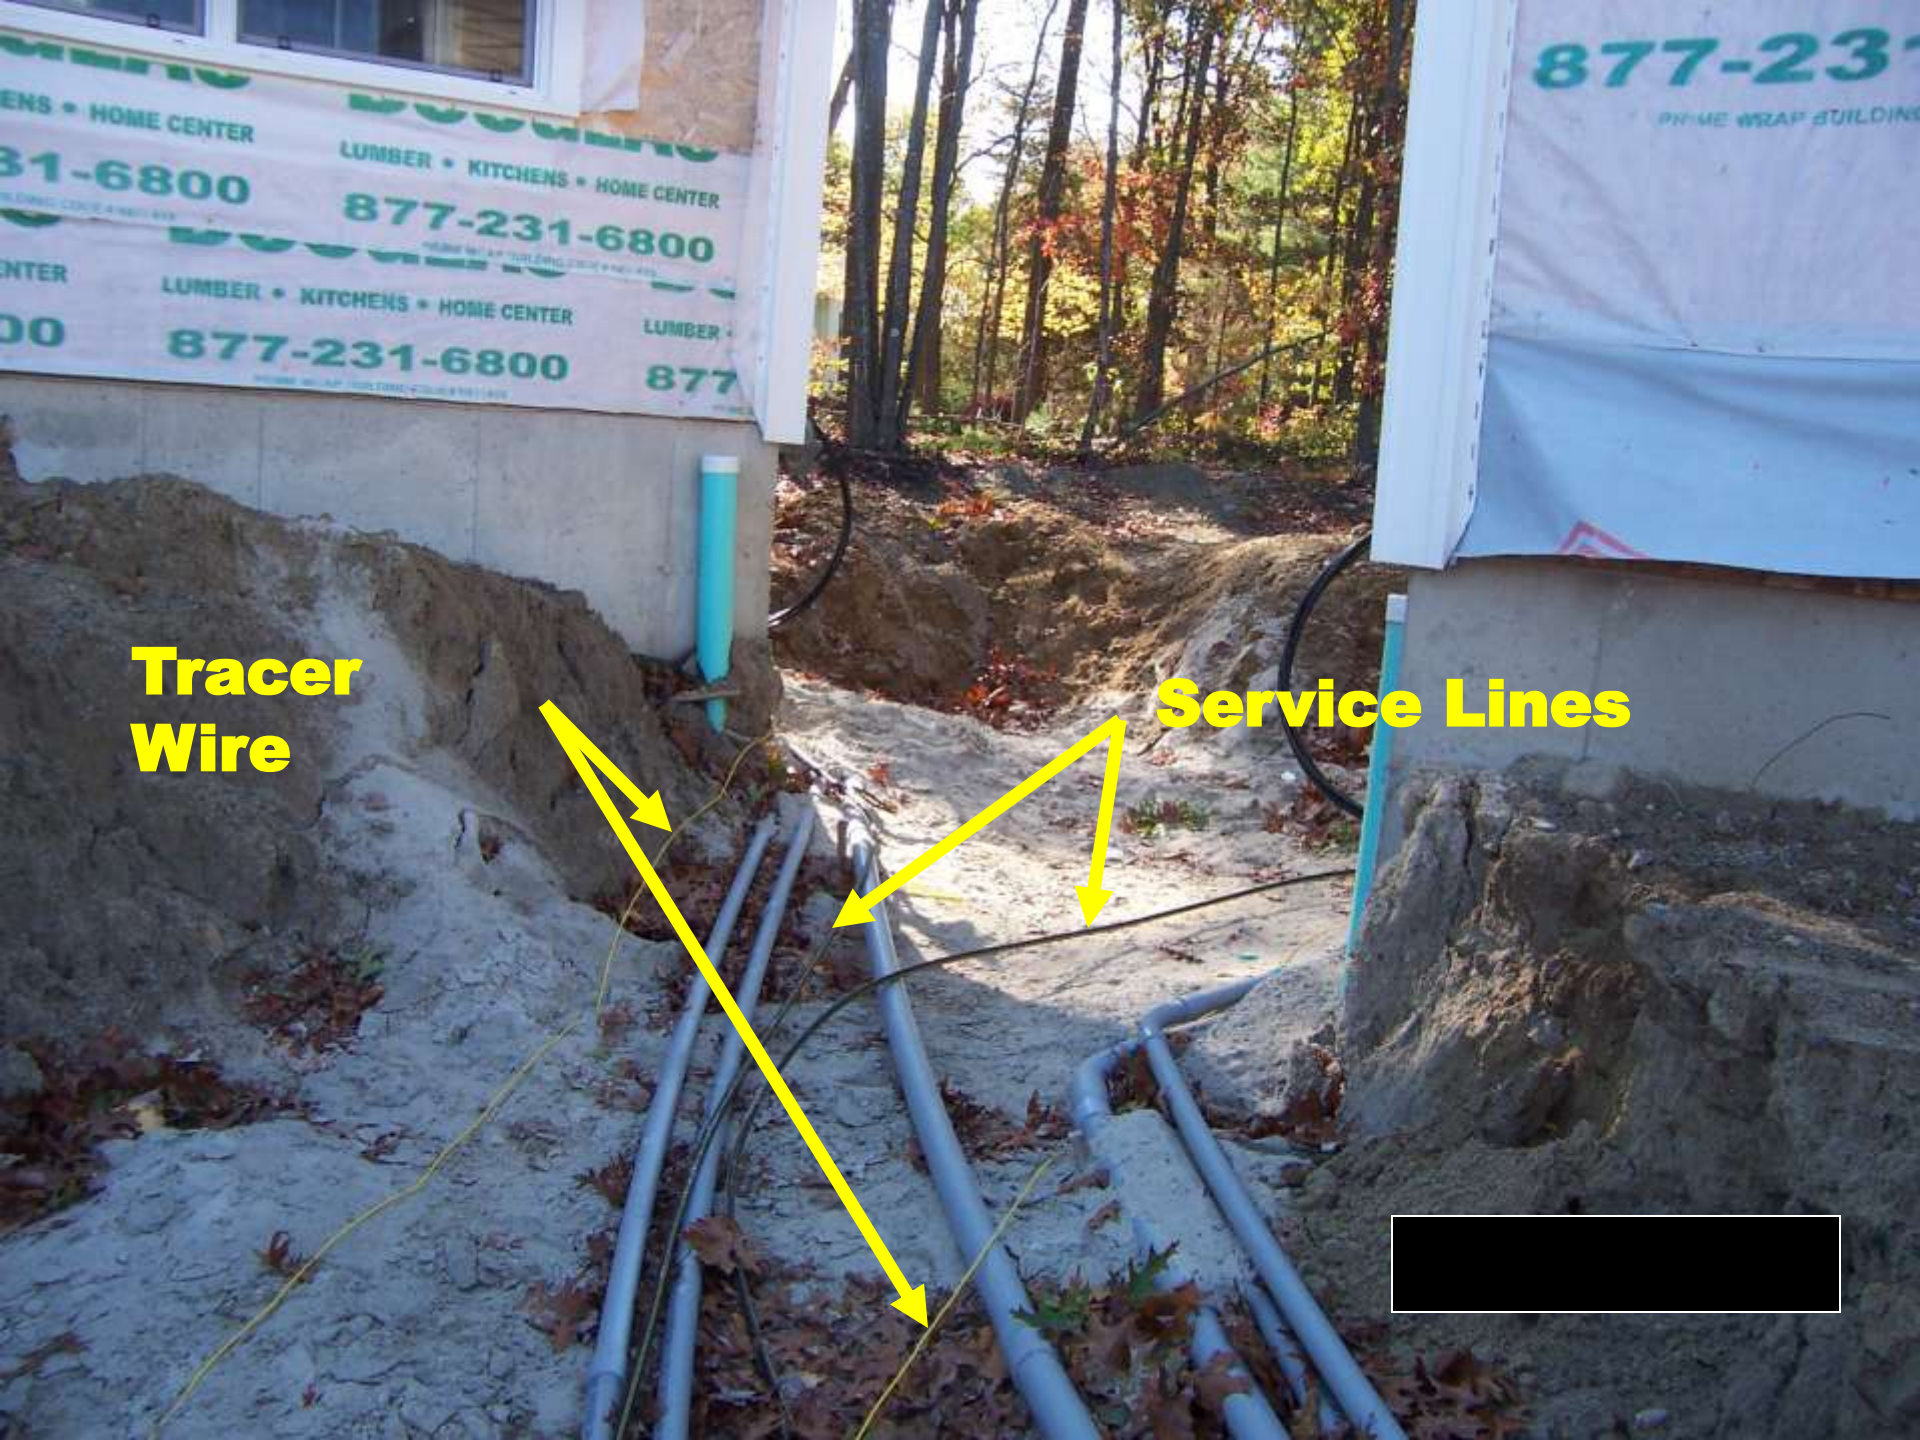
**Tracer  
Wire**

**Service Lines**

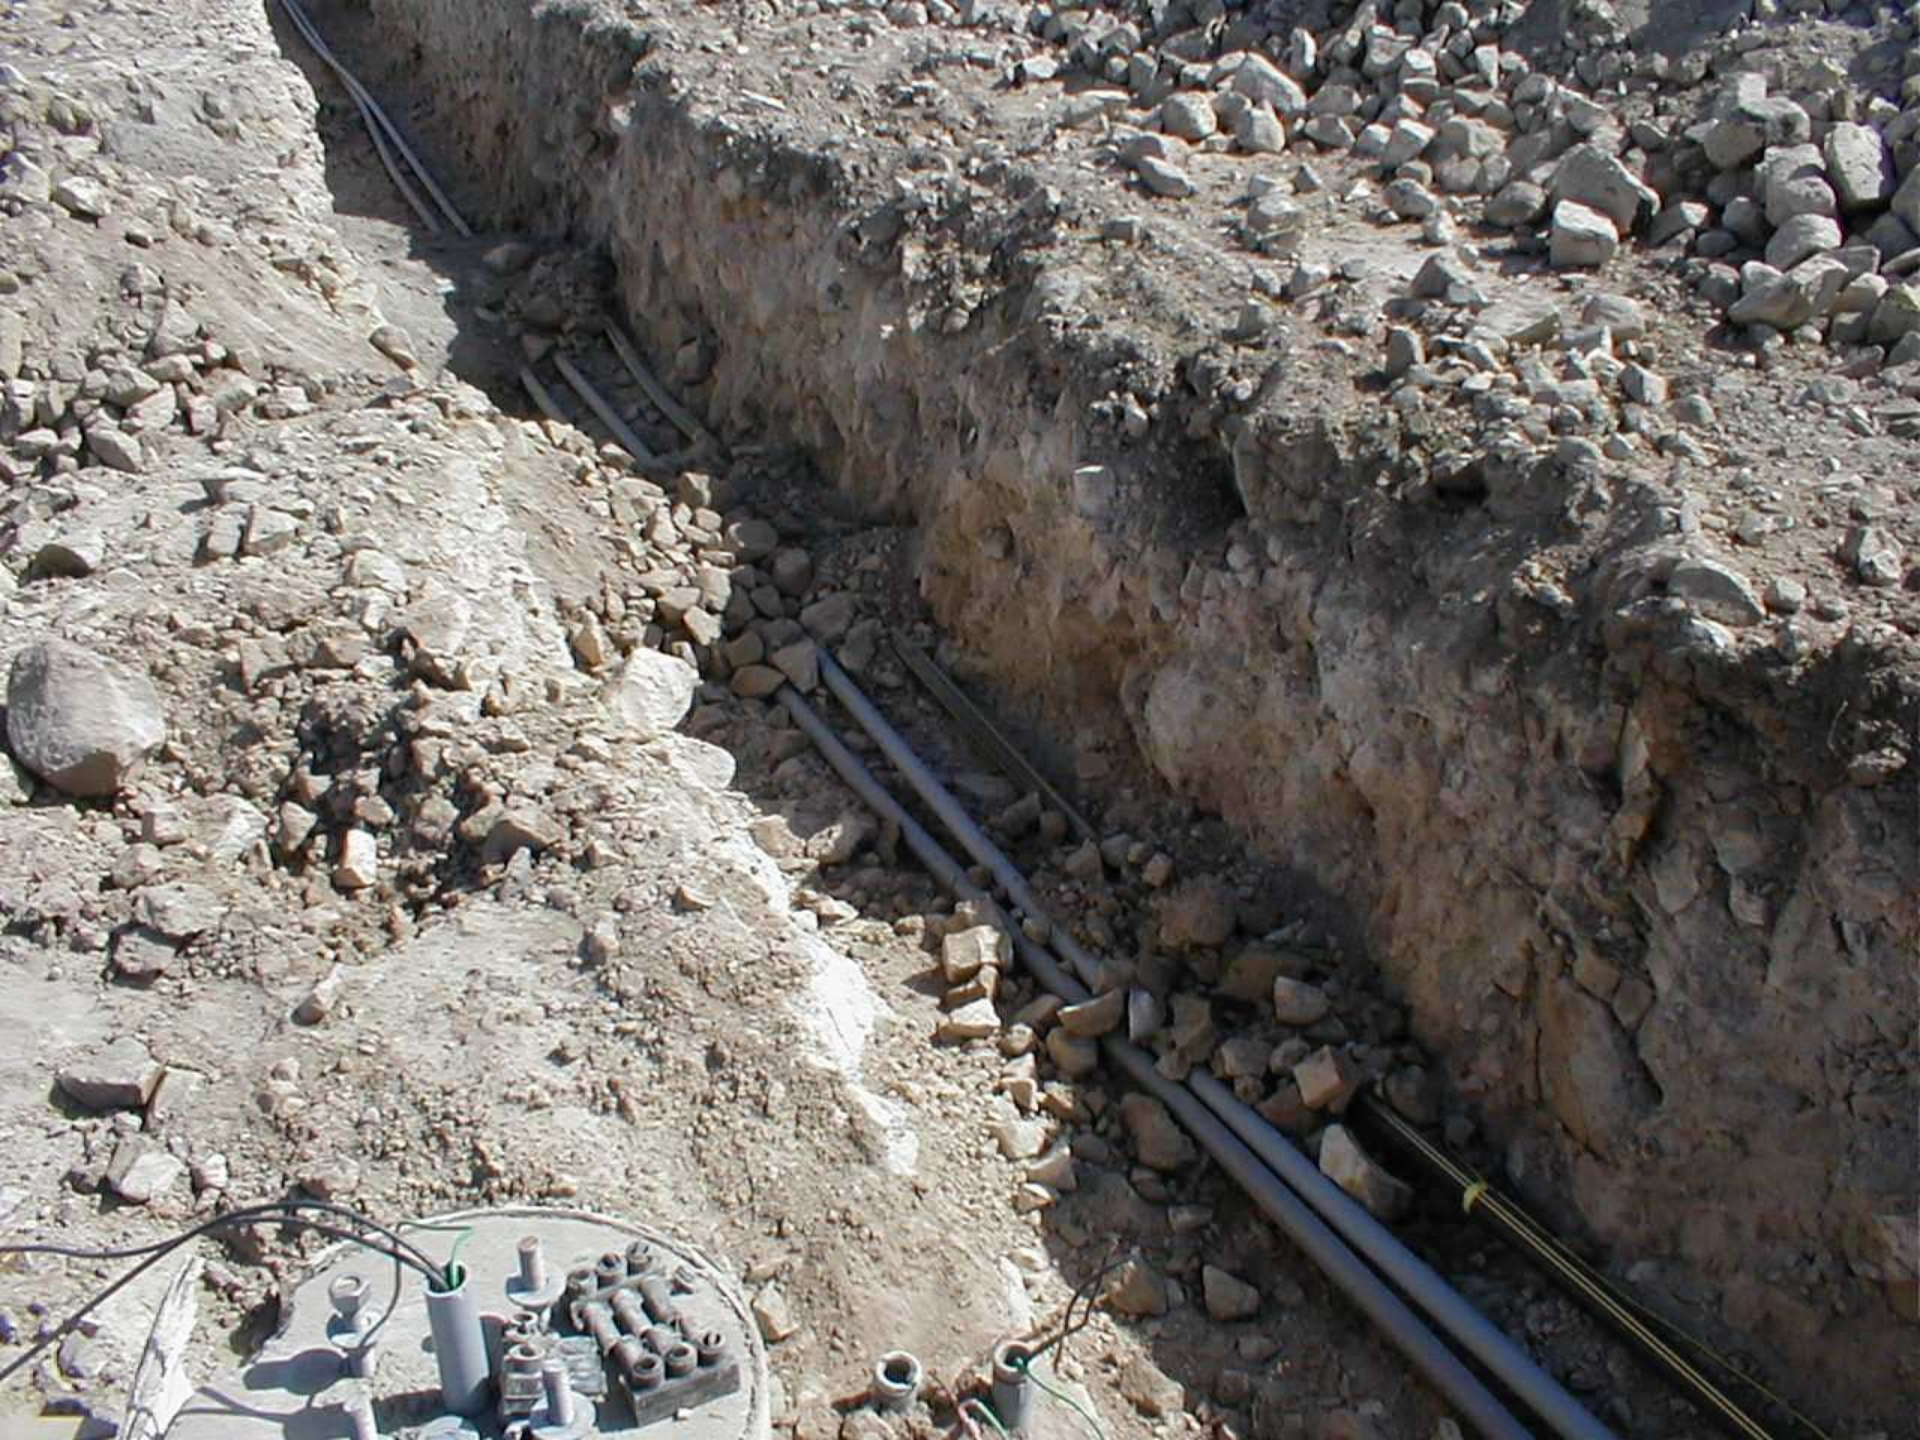
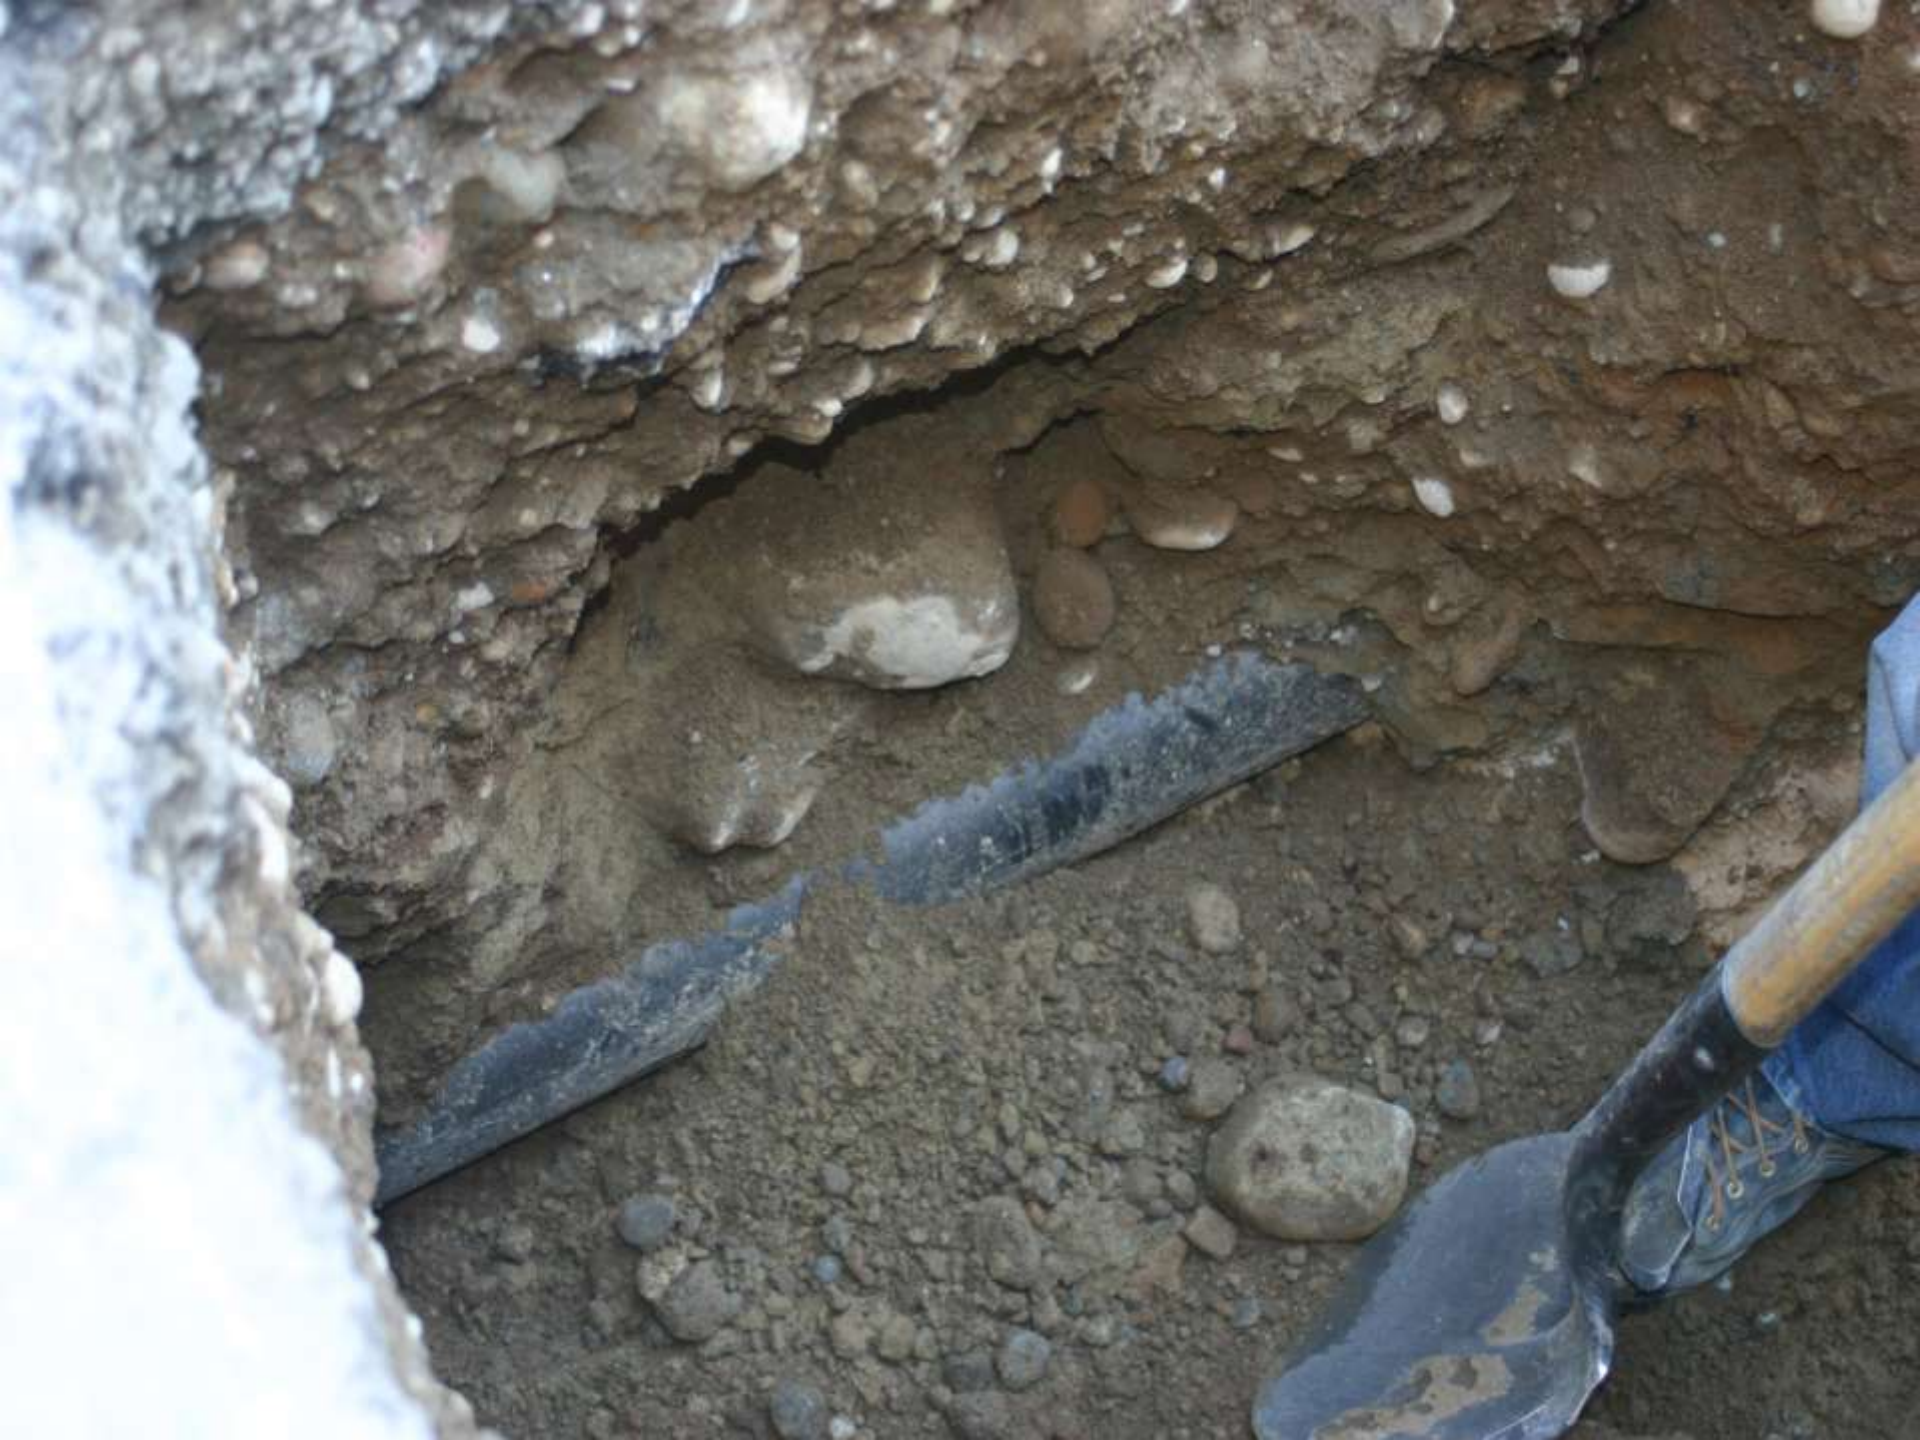
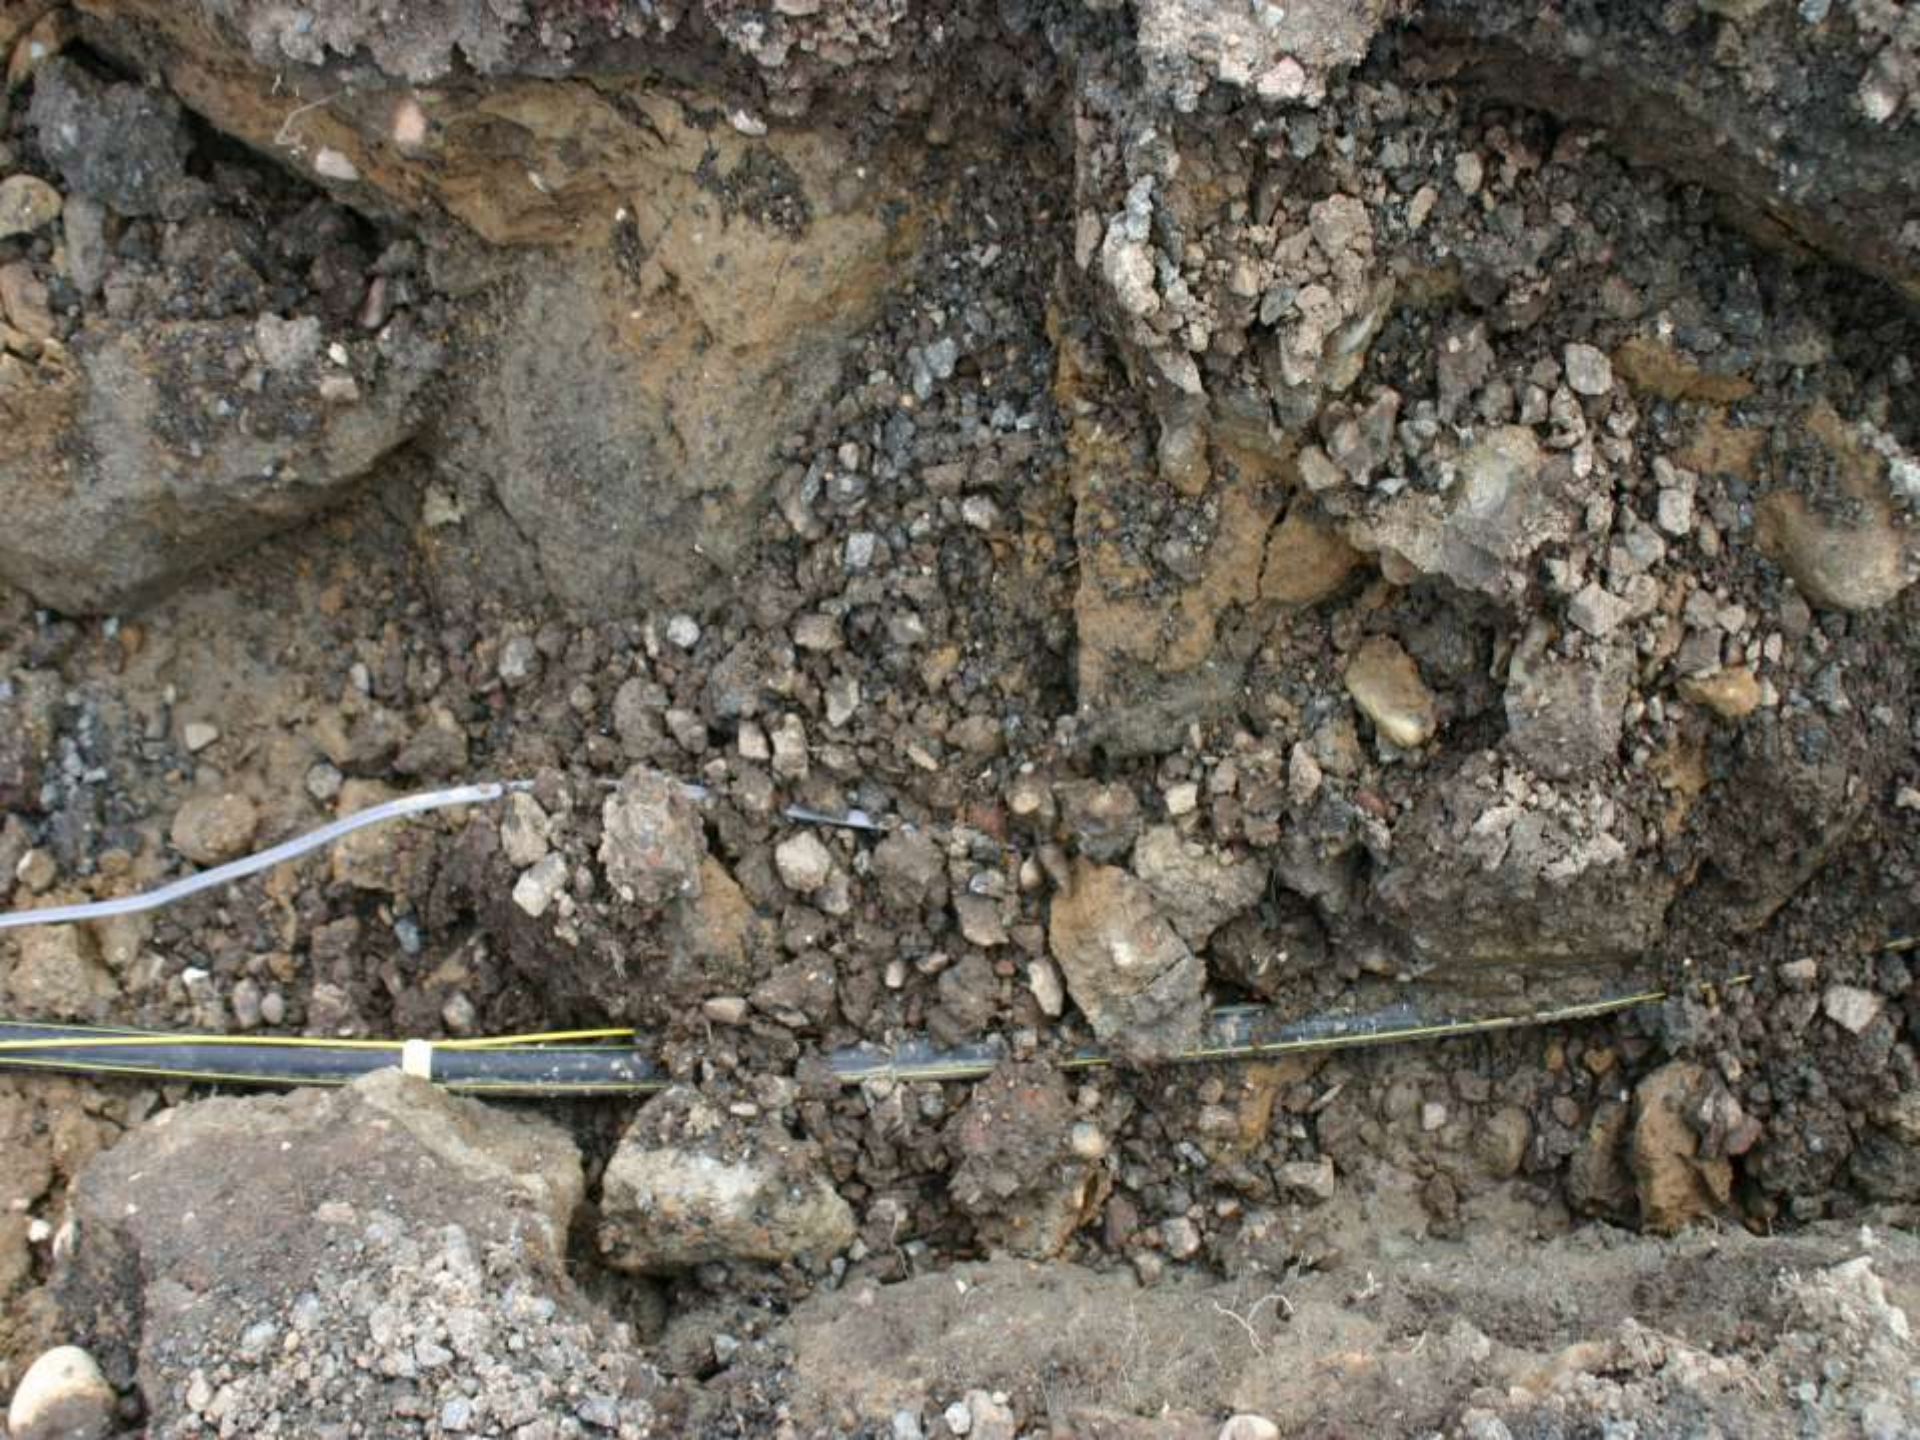
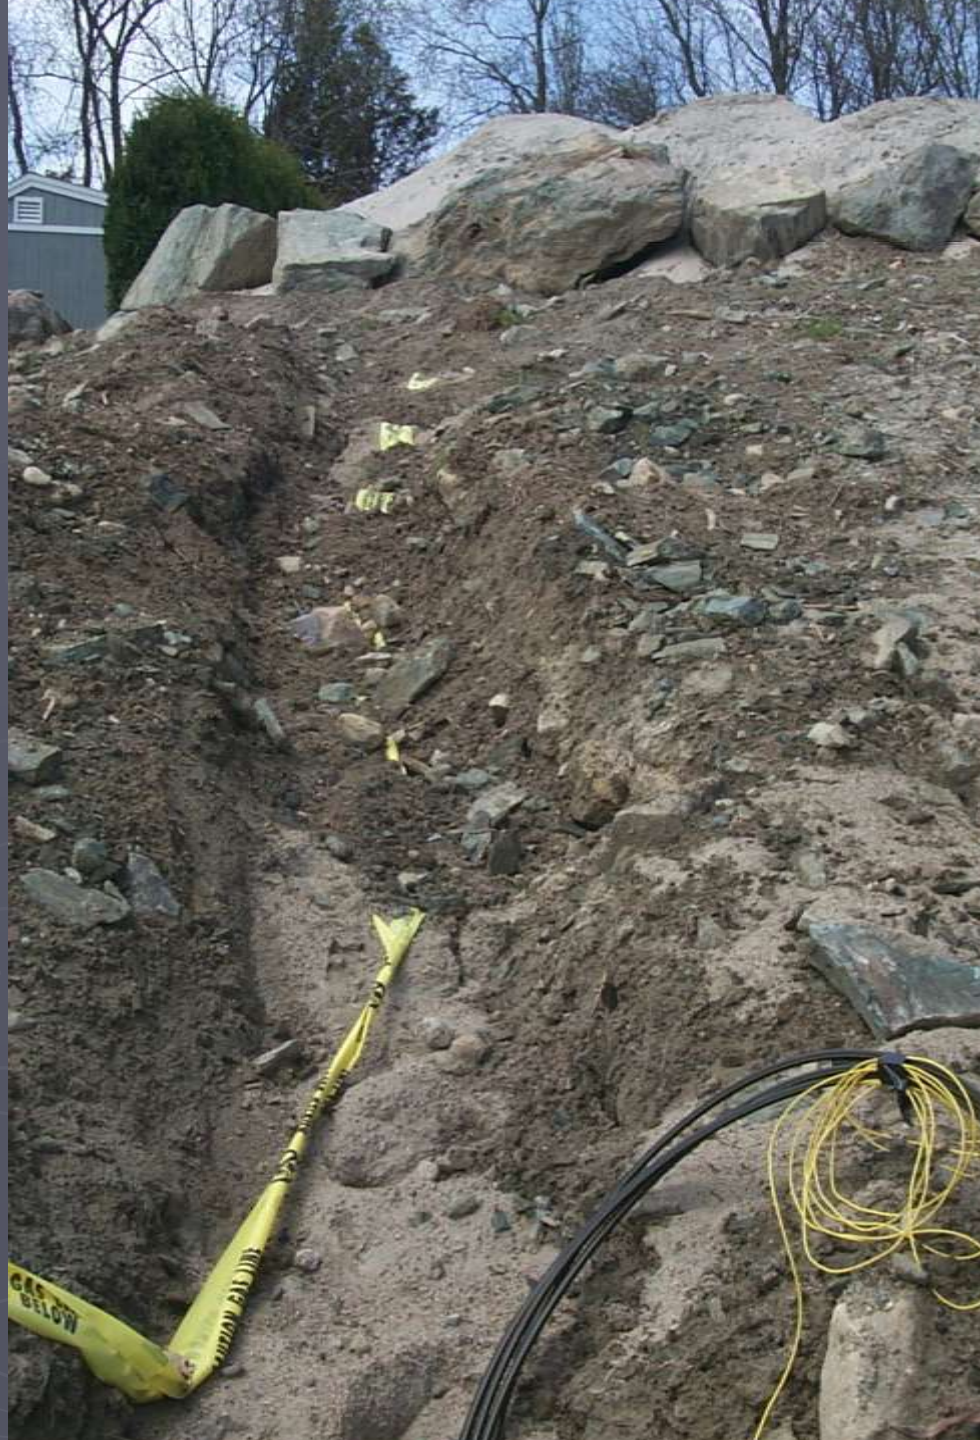
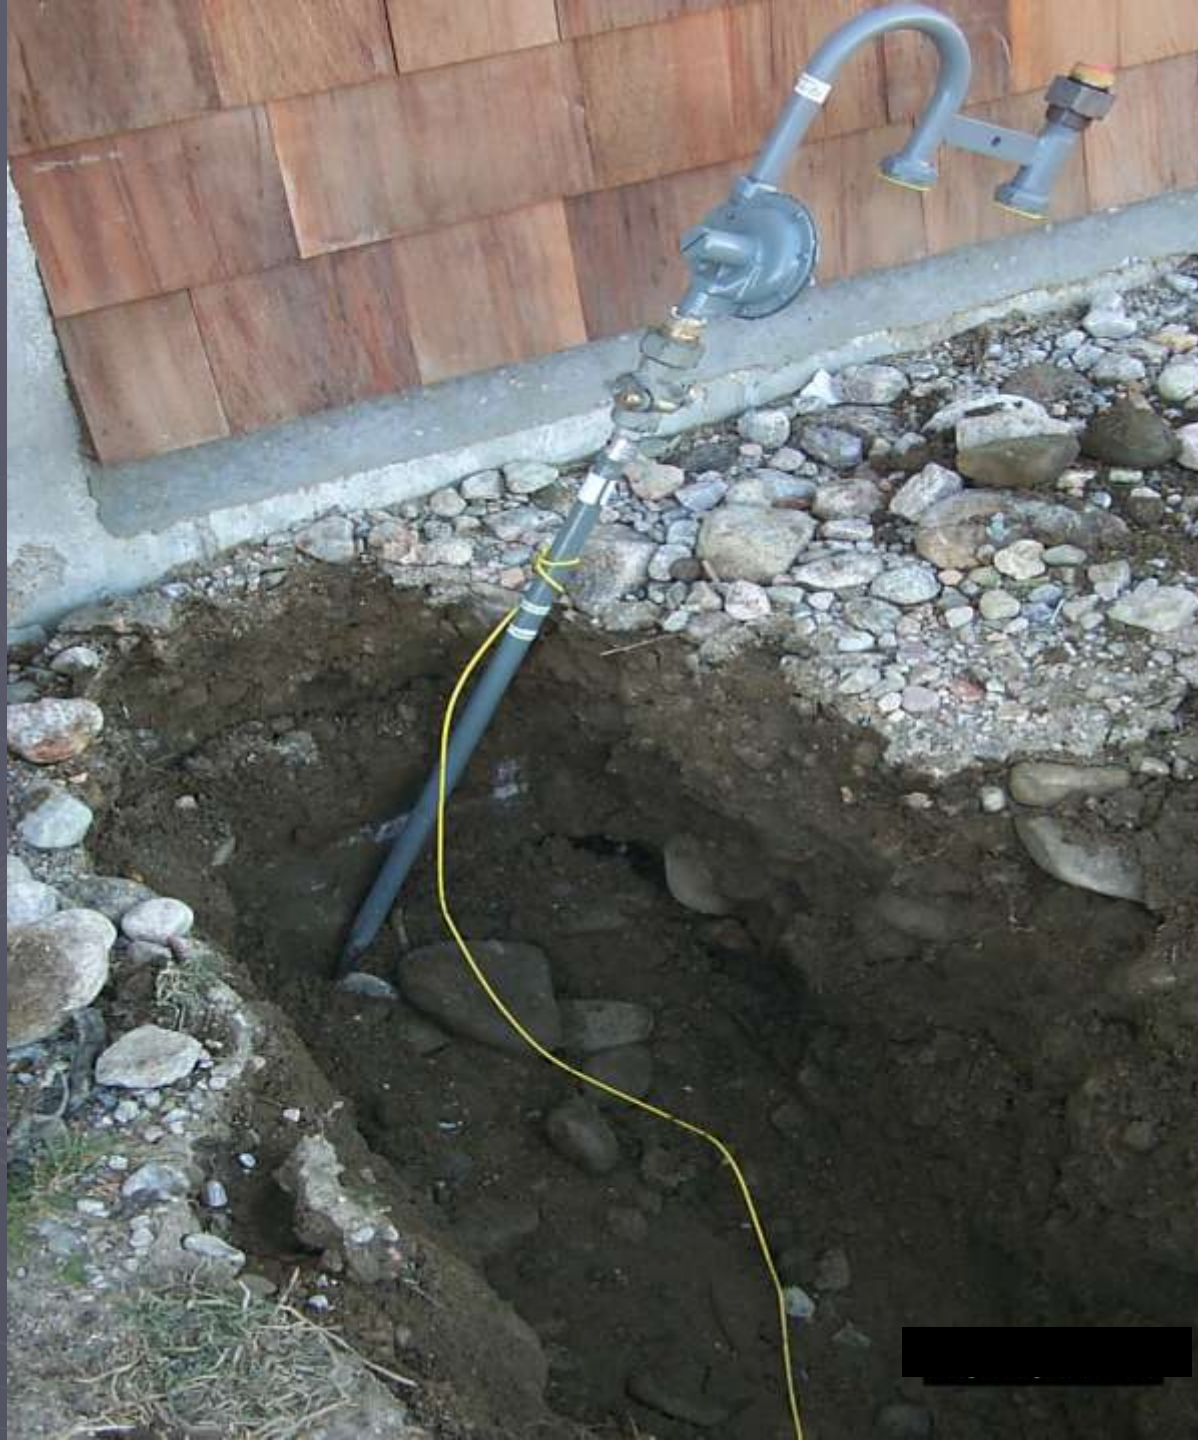
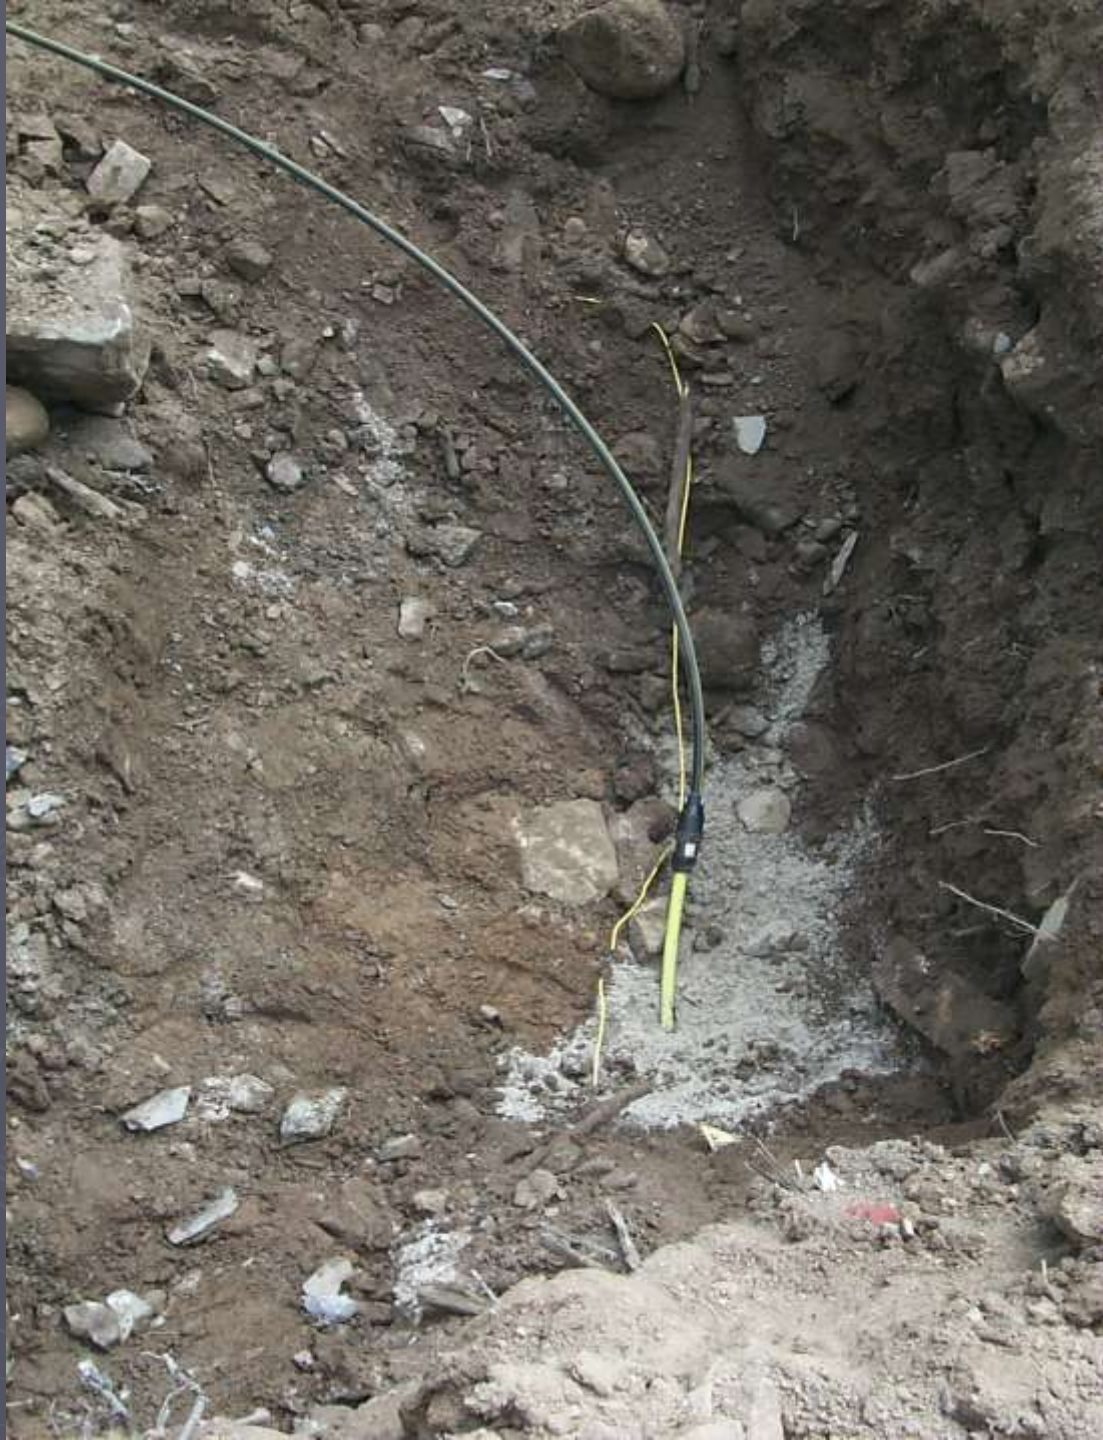
- ▶ **The Operator's contractor installed a 4" plastic main with improper backfill material. About 2500' (about a 1/2 mile) of the newly installed 4" gas main was replaced and select backfill was brought in.**

**§192.319(b)(2) - Backfill in a manner that prevents damage to the pipe from the backfill material.**

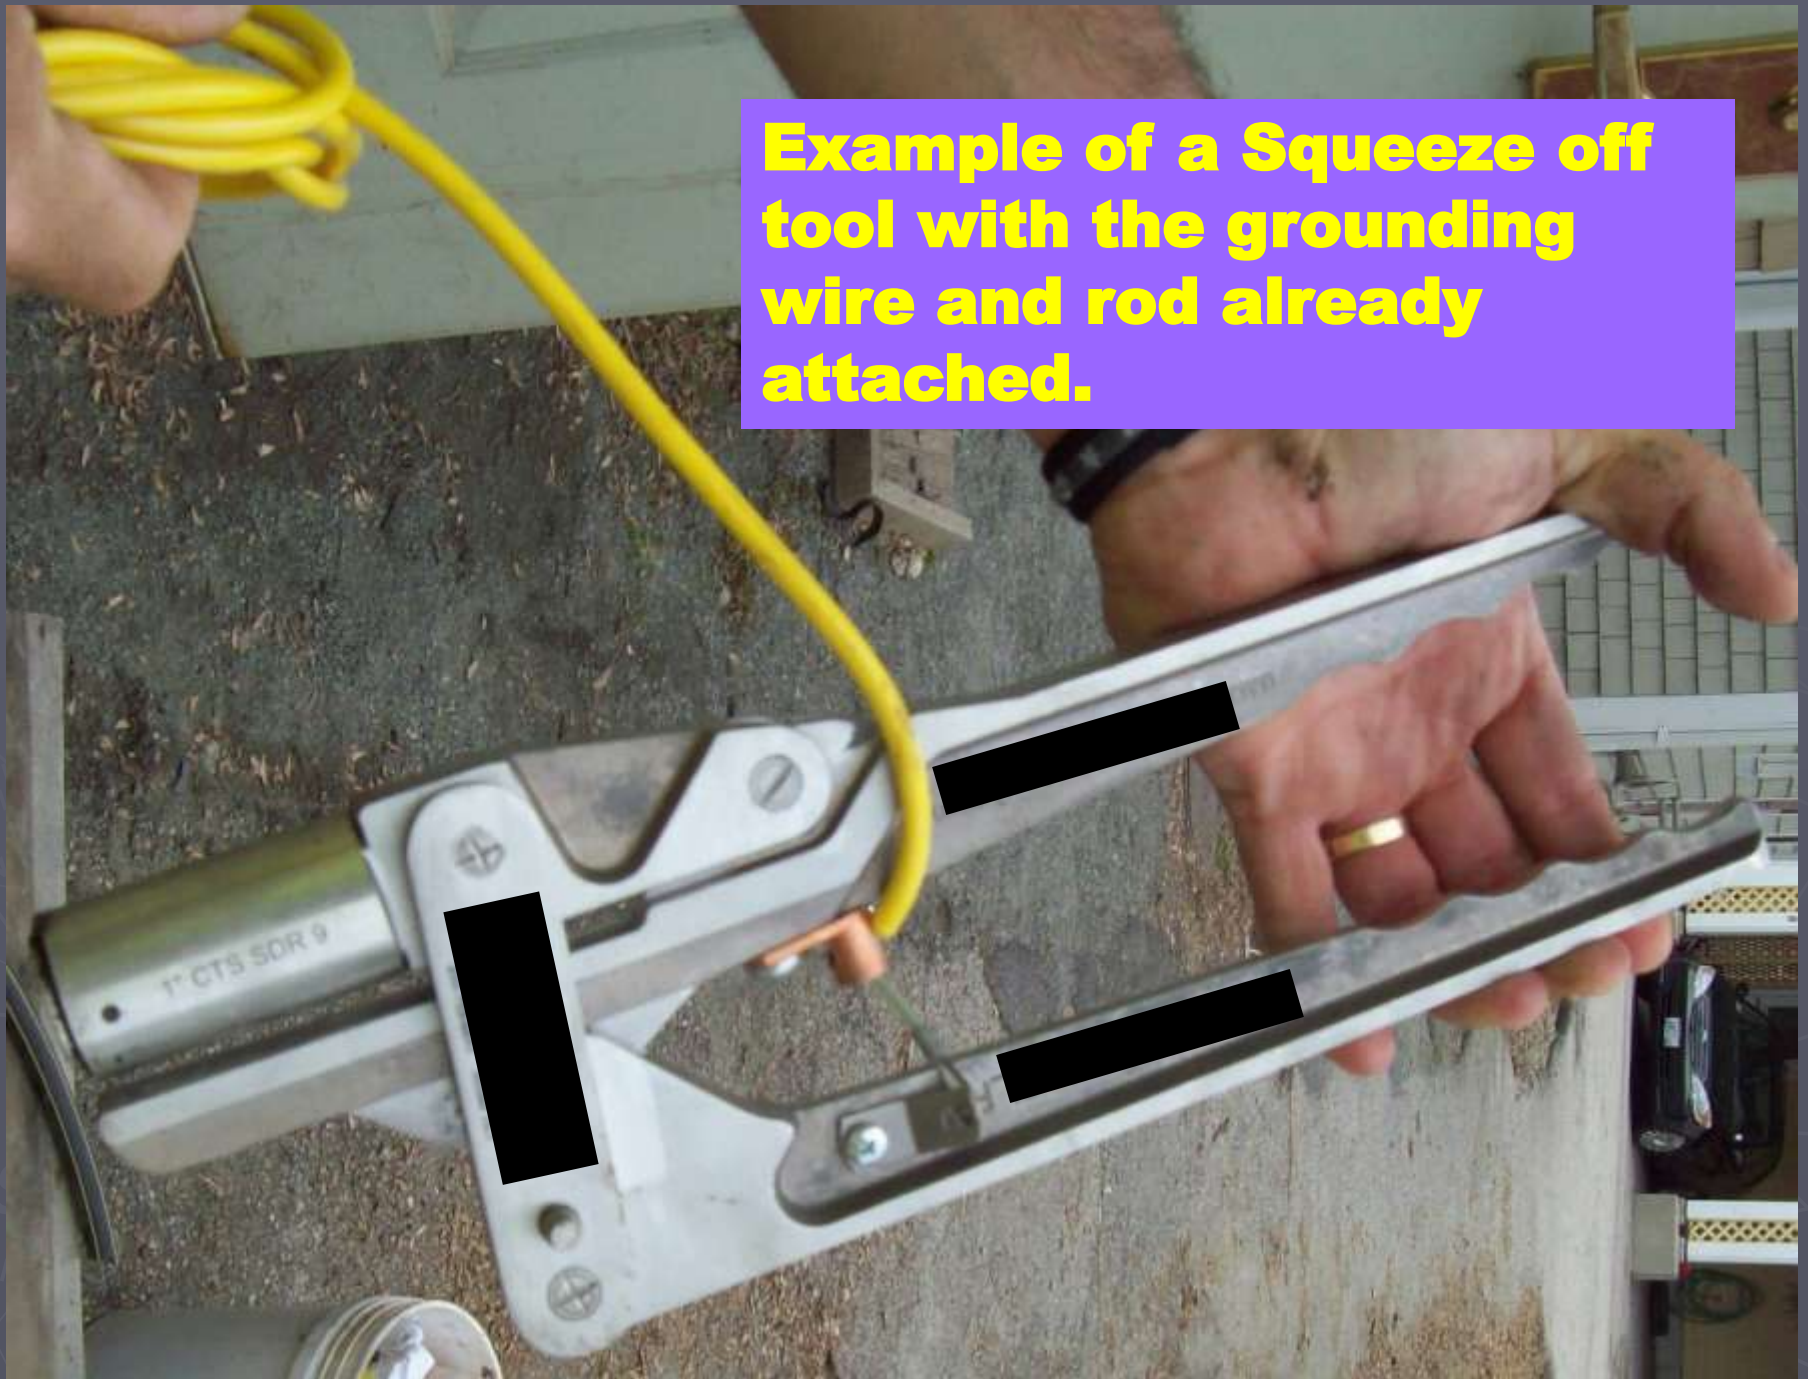
**Example of a Squeeze off tool with the grounding wire and rod already attached.**
